CASE STUDY MATERIAL SAMPLING & REINSTATEMENT

Project: Chain Bridge, Kemeys Commander, Monmouthshire
Recovery of samples and measurements of hanger rods

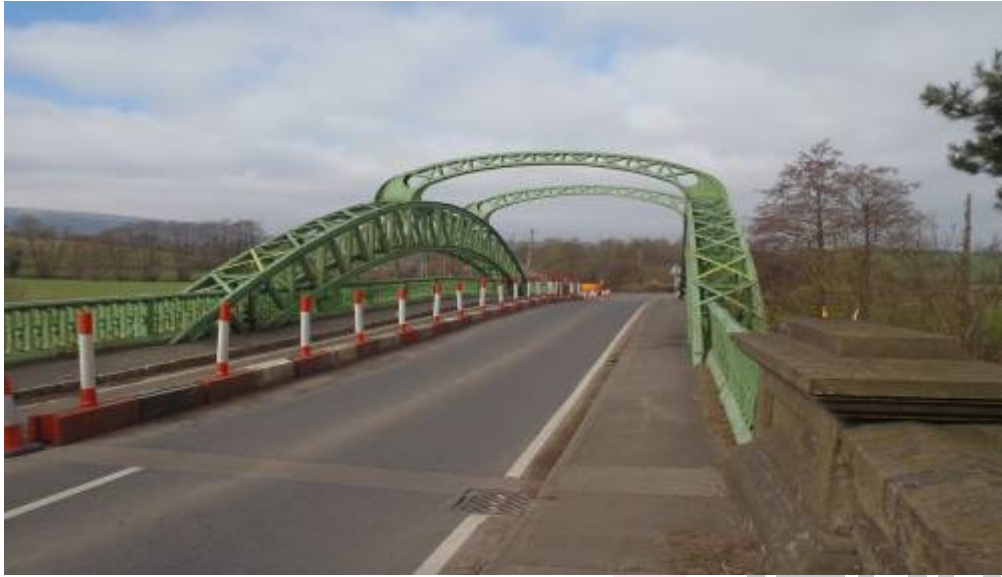
Up and Under were commissioned to recover 8 test samples for testing from existing components of the structure which comprise each leg of 4 No. horizontal cross-bracing elements to the top chord of the main arches. Reinstatement was achieved using Tension Control Bolts (TCBs) in order to match the existing rivets as closely as possible. The (TCBs) were tightened to a suitable bedding torque using a shear wrench securing the new cross-braces into position.

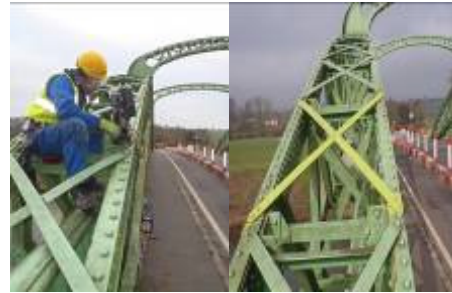
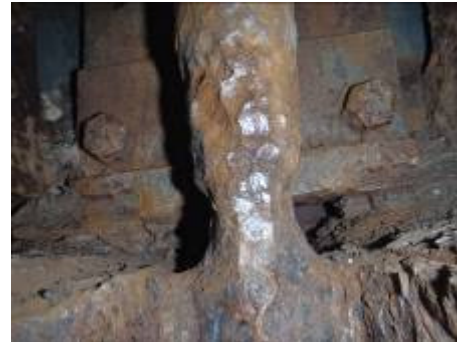
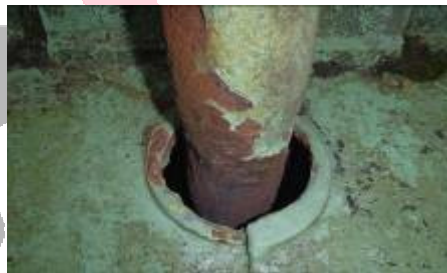
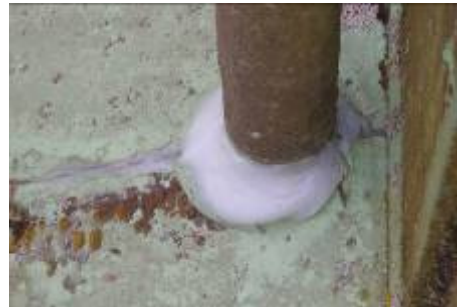
Measurements of the residual cross section at the bottom of hanger rods. These were cleaned using hand tools prior to repainting.

Holes in the parapet plinth cover plates were temporarily sealed with clear Vallance Building Silicone, a professional grade, highly flexible sealant, which remains elastic with 50% movement capability; is waterproof with strong, primerless adhesion to metal, fast curing with low dirt pick-up and low modulus. This preventing water running down the exposed holes and causing corrosion problems.
